**Building Preservation Guidelines
Historic Preservation Commission
City of New Richmond**

**Volume II
Buildings 15-31**

New Richmond
Wisconsin
54017

July 2000

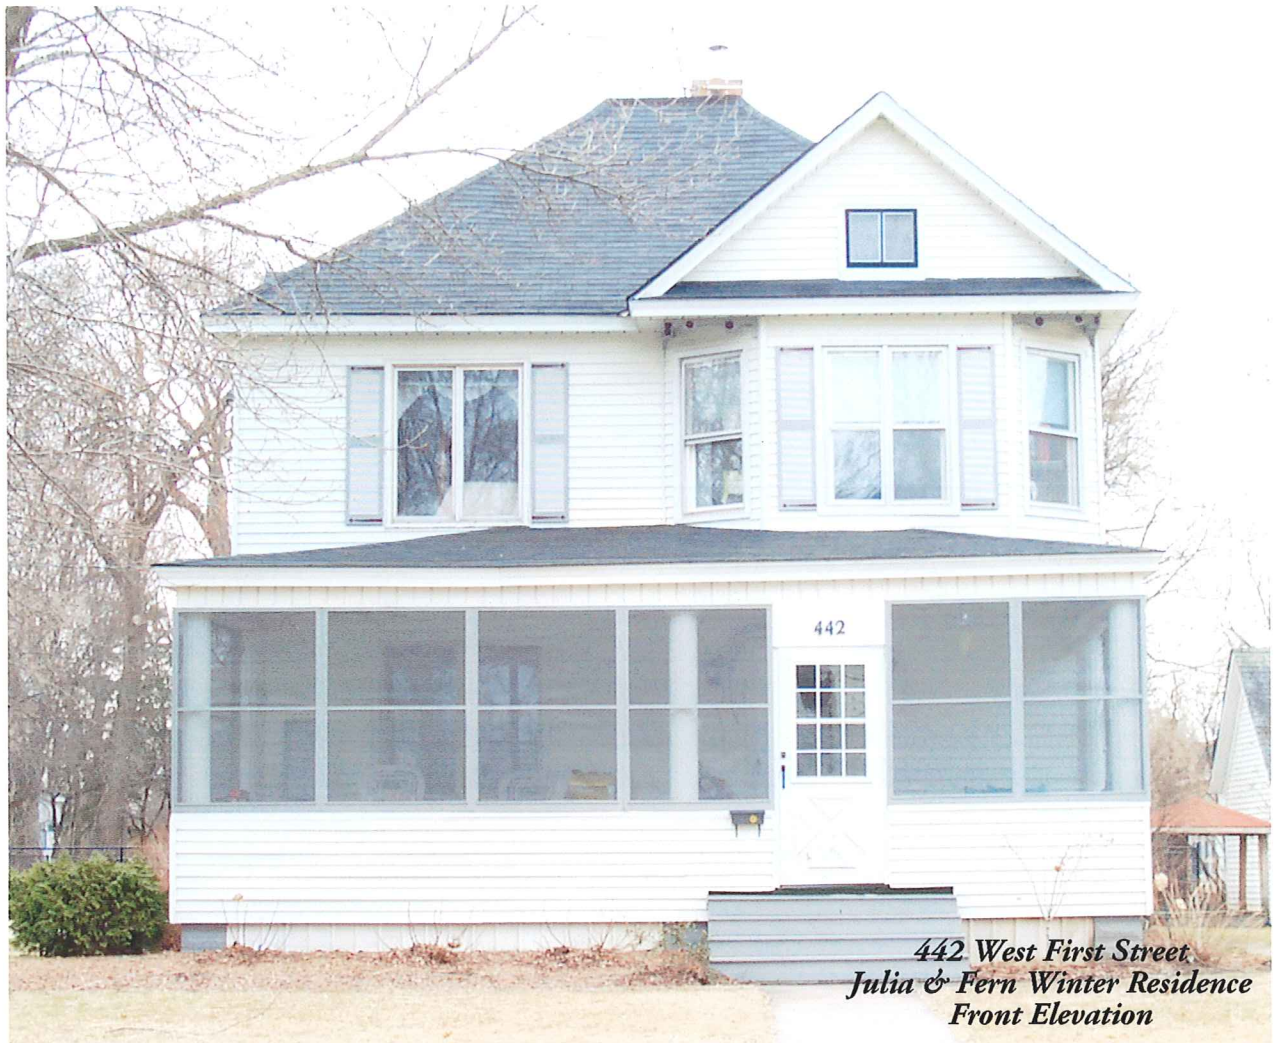
*442 West First Street
Julia & Fern Winter Residence
Front Elevation*

Under the aluminum porch exterior, a Colonial porch common to the original design of several houses in the area lies mostly hidden from view.

B. *First floor and second floor:* Some double hung windows have been replaced with casement or fixed windows. There is no historical precedent for windows other than double hung in homes such as this.

A. The original exterior siding of the house is likely under the metal finish and would contribute greatly to the character of the home if it were restored.

- A. Shutters are inappropriate to the design and should be eliminated.

D. *Screen Door:* Replace existing combination door with a screen door.

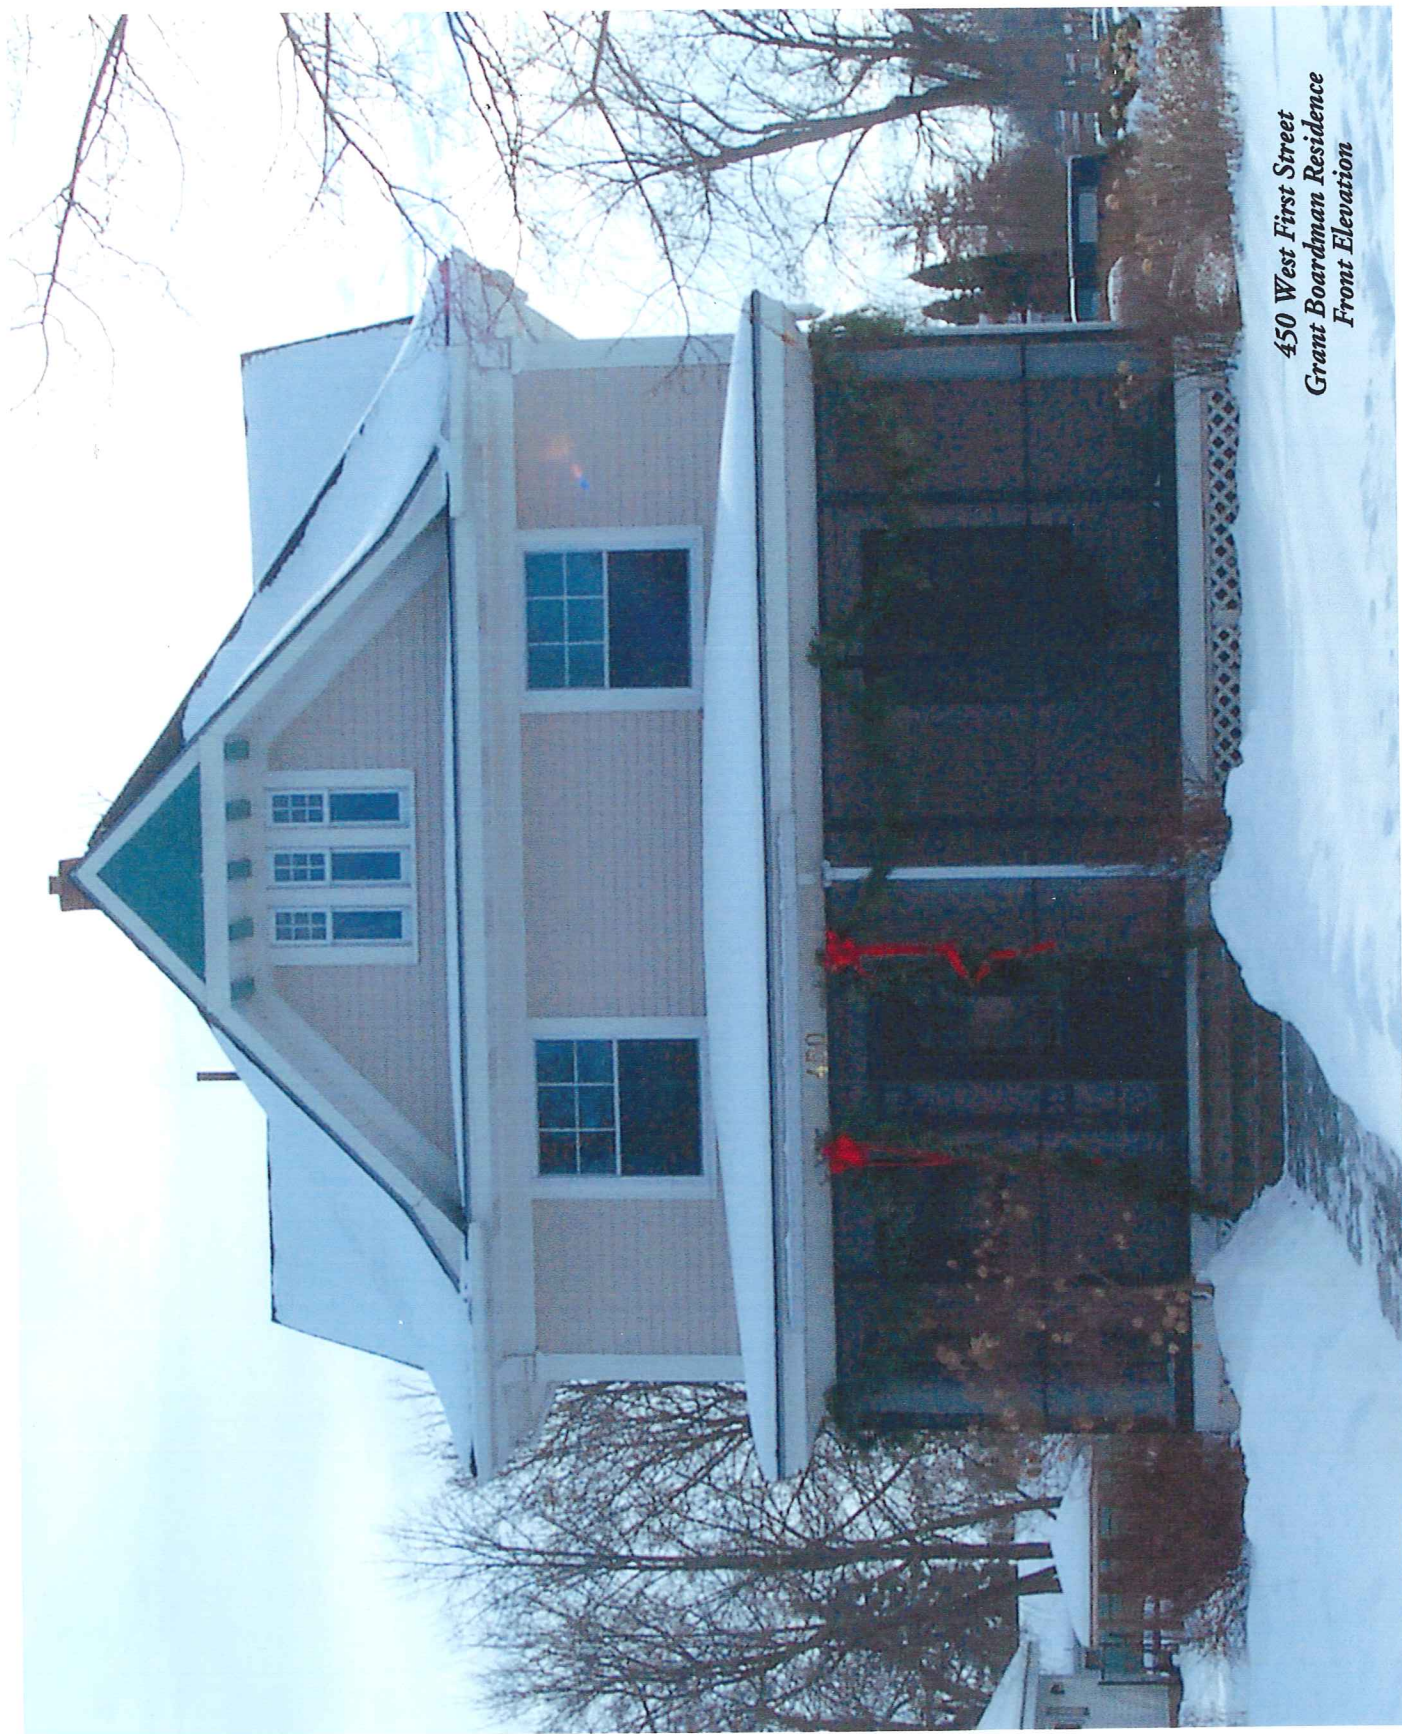
*450 West First Street
Grant Boardman Residence
Front Elevation*

A. Of the several homes in this area covered with metal siding this one was done most carefully. Trim is differentiated from siding by color. A minimum amount of metal finish was used and many original trim details are still seen in the exterior. Restoration of the original siding would still give a better feel to the house.

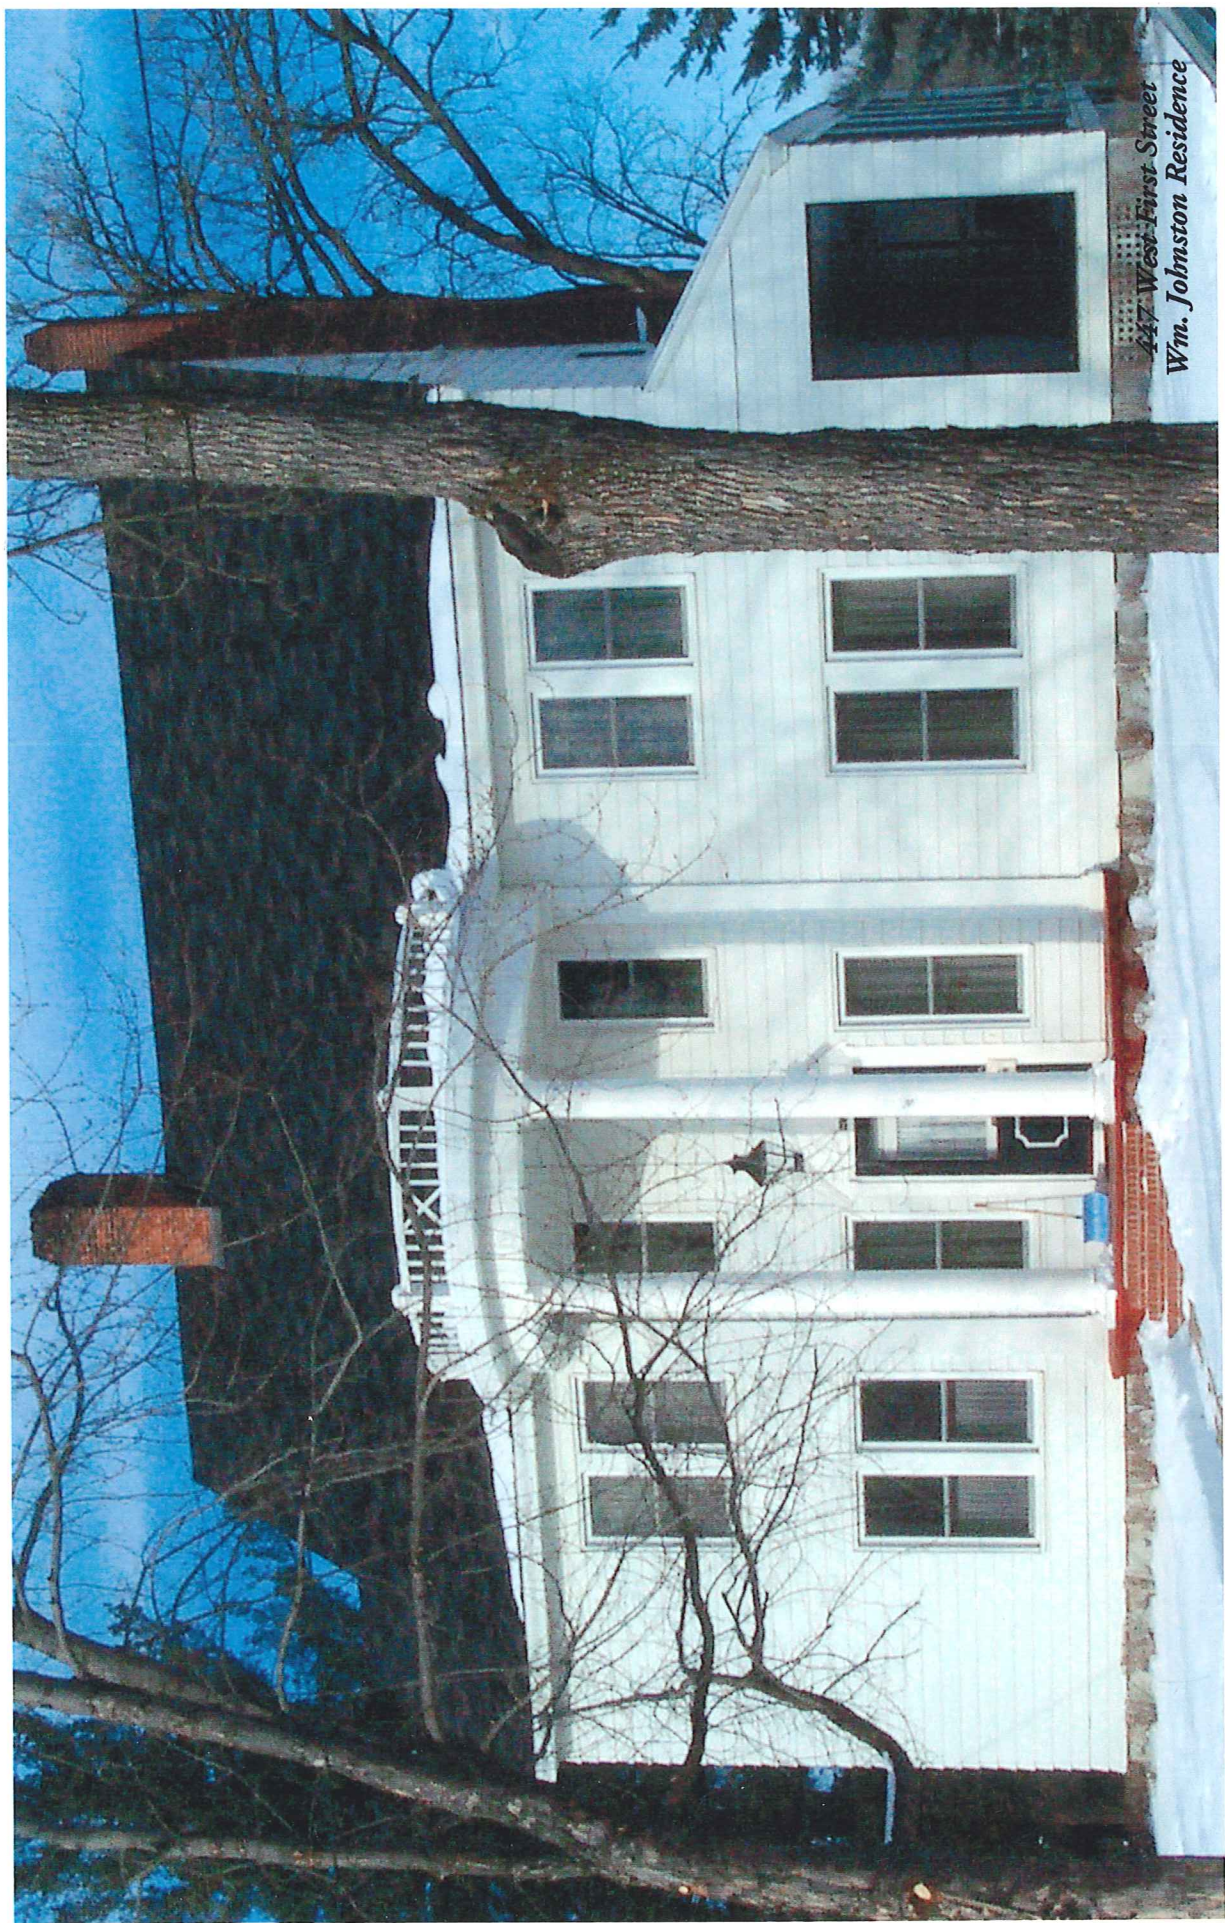
447 West First Street
Wm. Johnston Residence

Fifty years ago the house was radically altered and redesigned in the Colonial Revival style. While this redesign was done in a competent and consistent manner, it lacks the distinguished design character of the unique design produced by Buffington.

A. The windows apparently have been replaced. One over one light window are unsympathetic to the Colonial character. In the nineteen forties rendition of the Colonial, divided light were often used in the upper sash. In the Colonial era both sash would have been six or eight light sash. Divided light muntins might be added to the existing windows to bring back some of the character.

A. Siding in the 1940's design was white painted cedar shingle. In all probability the shingles are still there and can be restored when the unsympathetic siding is removed.

A. The 1940's redesign included brackets under the eaves. These may have been survivors of the Buffington design. In any case they should be replaced. Presumably there is a frieze board on the top of the exterior wall, under the eave to which these were attached. Paint lines on this and the soffit as well as historic photographs should be sufficient to define the original character of the brackets.

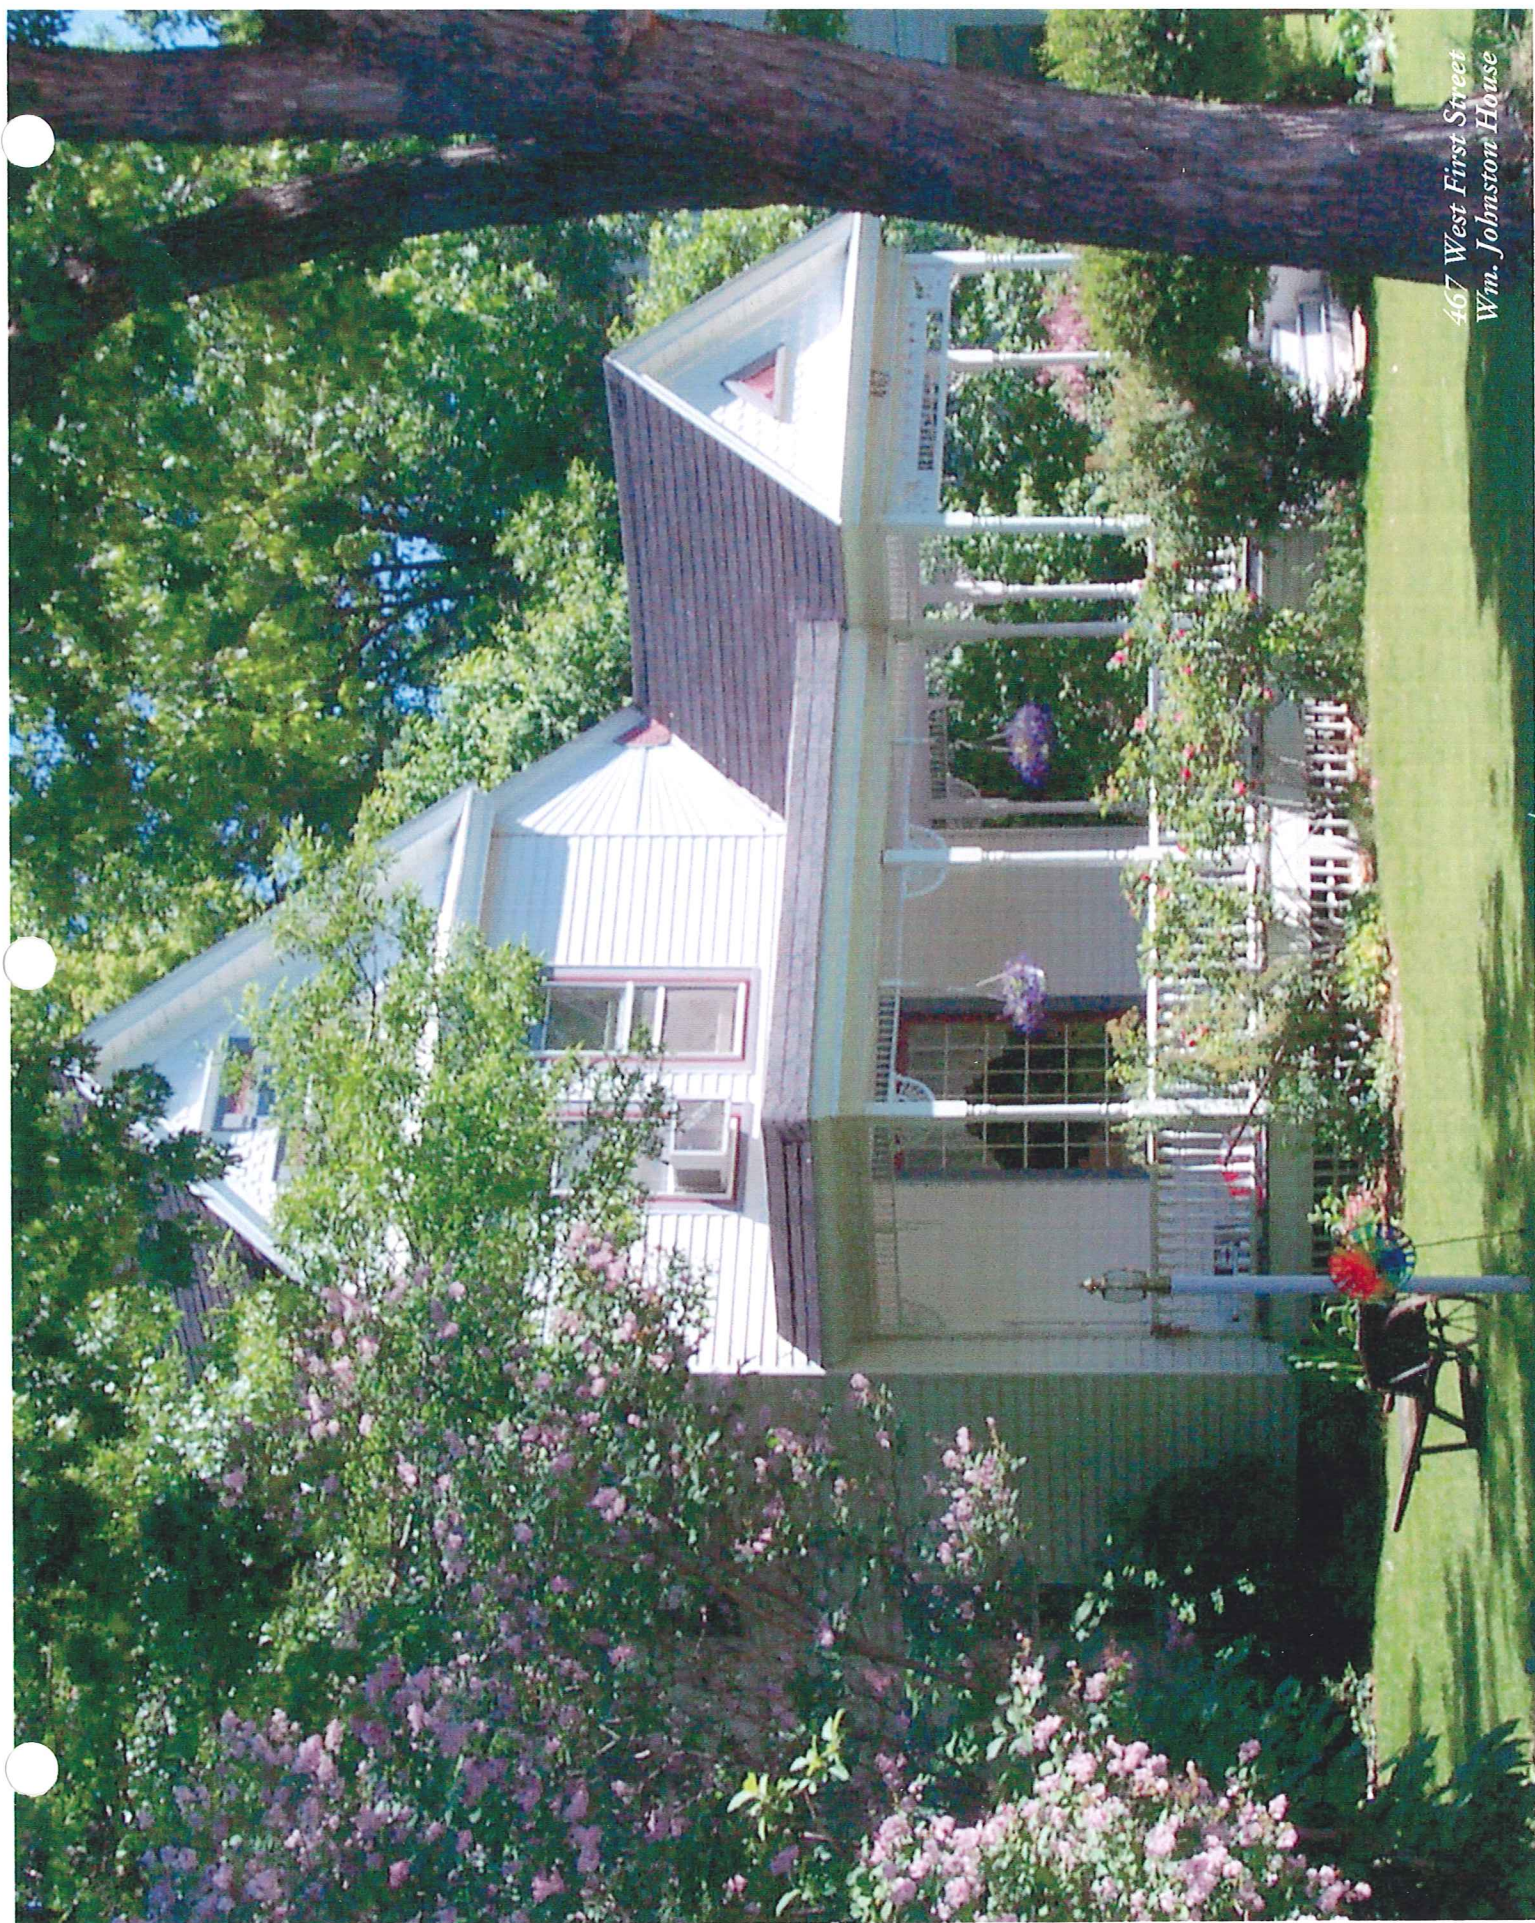
467 West First Street
Wm. Johnston House

- A. *Header sections:* The original porch trim details were in the Eastlake style. The header trim in the two bays to the left at one time matched the header trim over the front steps. These two header sections have been replaced with a lighter smaller "gallery". This breaks the extremely strong horizontal line created by the original design that served as a unifying element in the entire facade of the house. Replacing these sections is a high priority.

- B. *Railing above porch roof:* Also missing is the original railing around the porch roof. At one time the west window on second floor was a door to the deck on top of the porch roof. This door may not have been original. Many Victorian era porches had railings without proper access to the roof, so replacing the railing without the door would be reasonable.

A. All of the windows have been replaced at one time or another. One over one light sash, while available at the time, would almost never be used in this sort of home. Two over two sash were common where budget was the tightest, though four over four were also used in these houses. The front of this or other houses might have been embellished with Queen Anne sash or cottage sash in the upper sash.

C. *Attic:* The attic windows have been replaced with sash that are shorter than the original. It is possible that these original included Queen Anne divided light units.

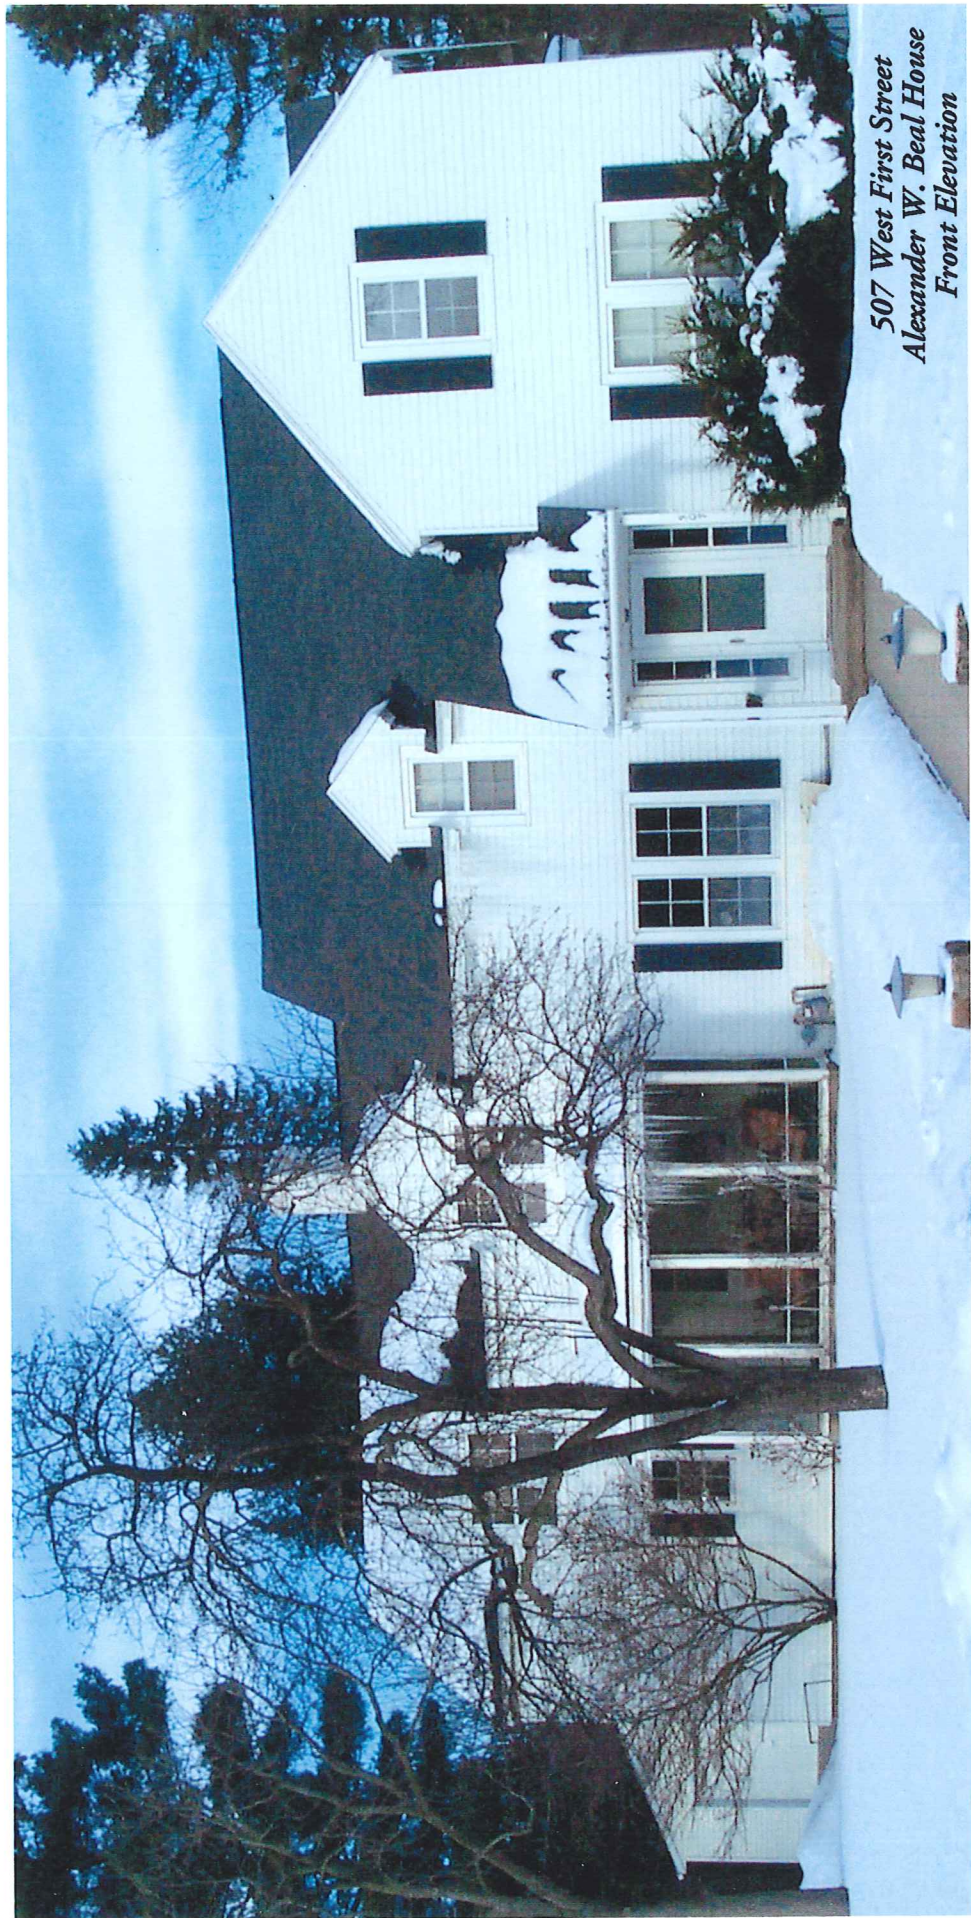
*507 West First Street
Alexander W. Beal House
Front Elevation*

A. Early photos reveal that it once had functional shutters. The present fake shutters, which are of inadequate width for the size of the windows, are inappropriate. The design would be more clear without these fake shutters as they are not placed consistently throughout the design.

A. Photos indicate that the original south porches include large box posts of Greek Revival character. Reintroducing these porches would be an important objective in the restoration of the house as the present entries are somewhat understated.

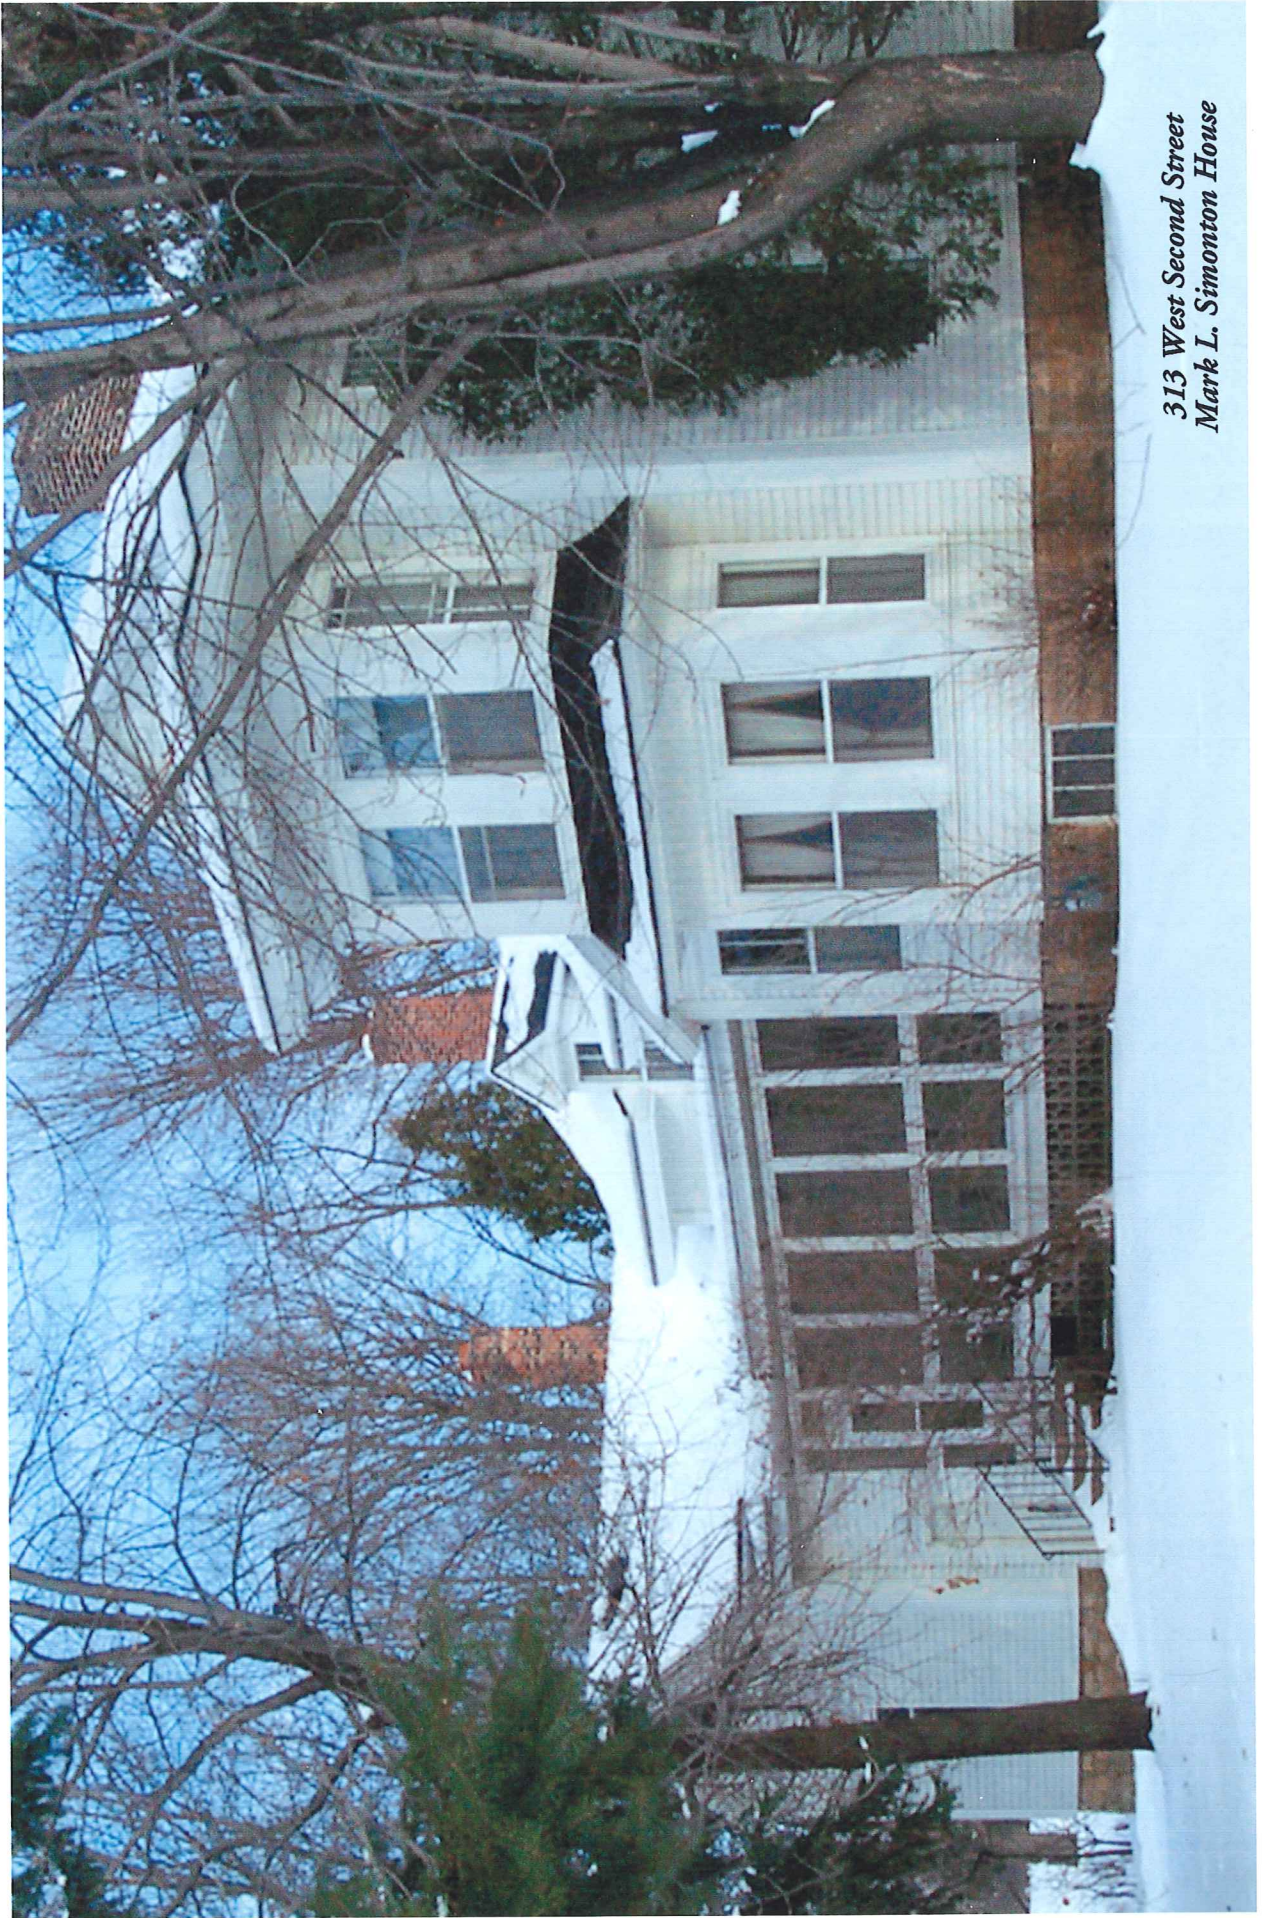
*313 West Second Street
Mark L. Simonton House*

A. *Window placement:* Houses of the 1870's were balloon framed meaning that the studs in the walls extended from the floor of first floor to the eave of the roof. Because of this windows were invariably placed one above another. The large window on the south wall on first floor and the windows on the east wall were added. The front elevation started with two windows centered under the windows above and the window on the east wall was centered on the window on second floor. Replacement of the two newer windows on the first floor with three appropriately sized and placed windows should be contemplated.

A. The chimney should have a decorative corbel at the top.

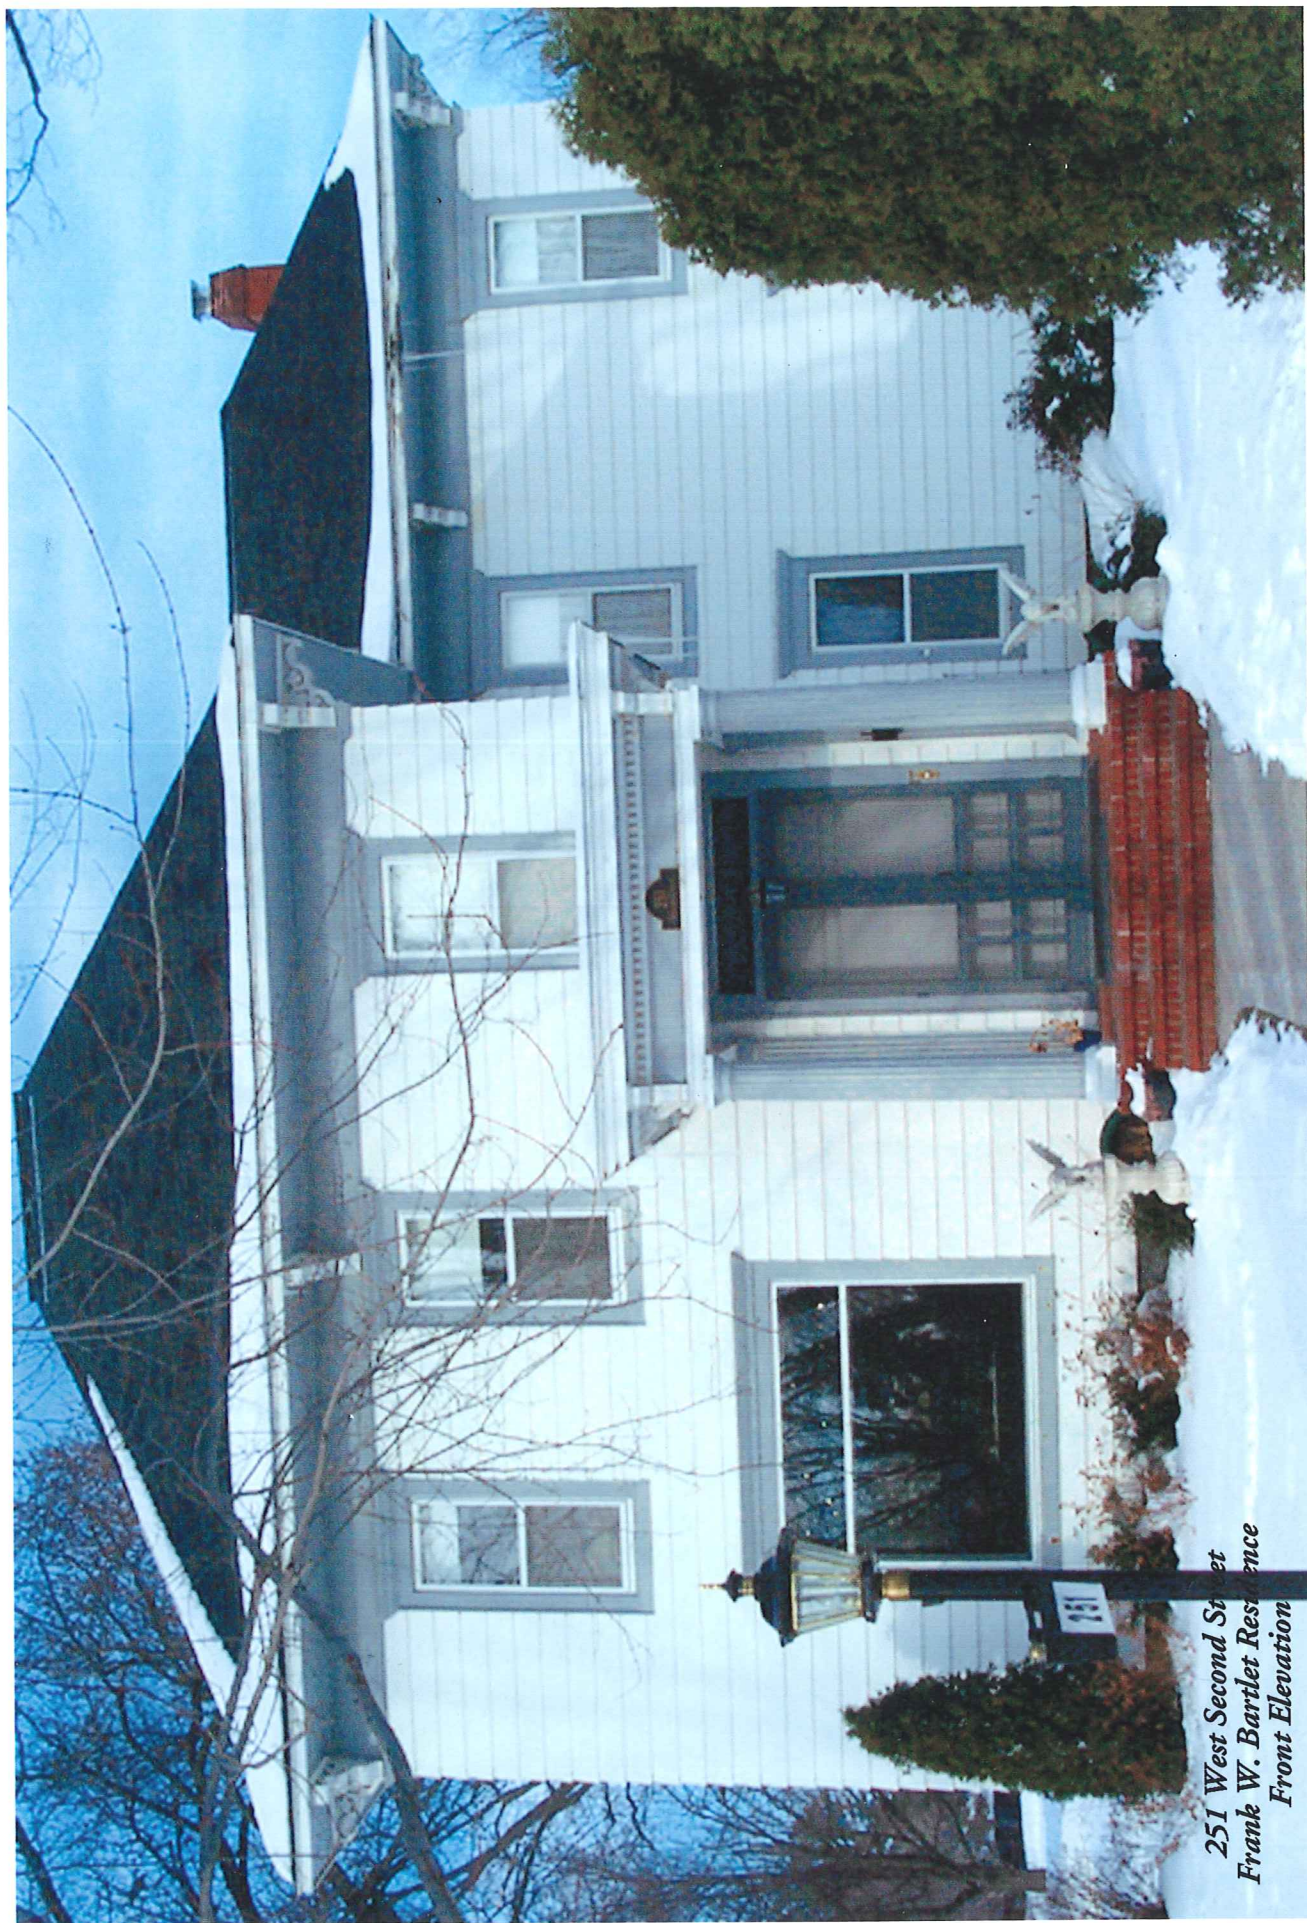
251 West Second Street
Frank W. Bartlett Residence
Front Elevation

A. Windows in this house have been replaced with one over one light windows where formerly they had been two over two light windows. In this particular house with its early history and strong details, in fact six over six light sash would have been fully appropriate.

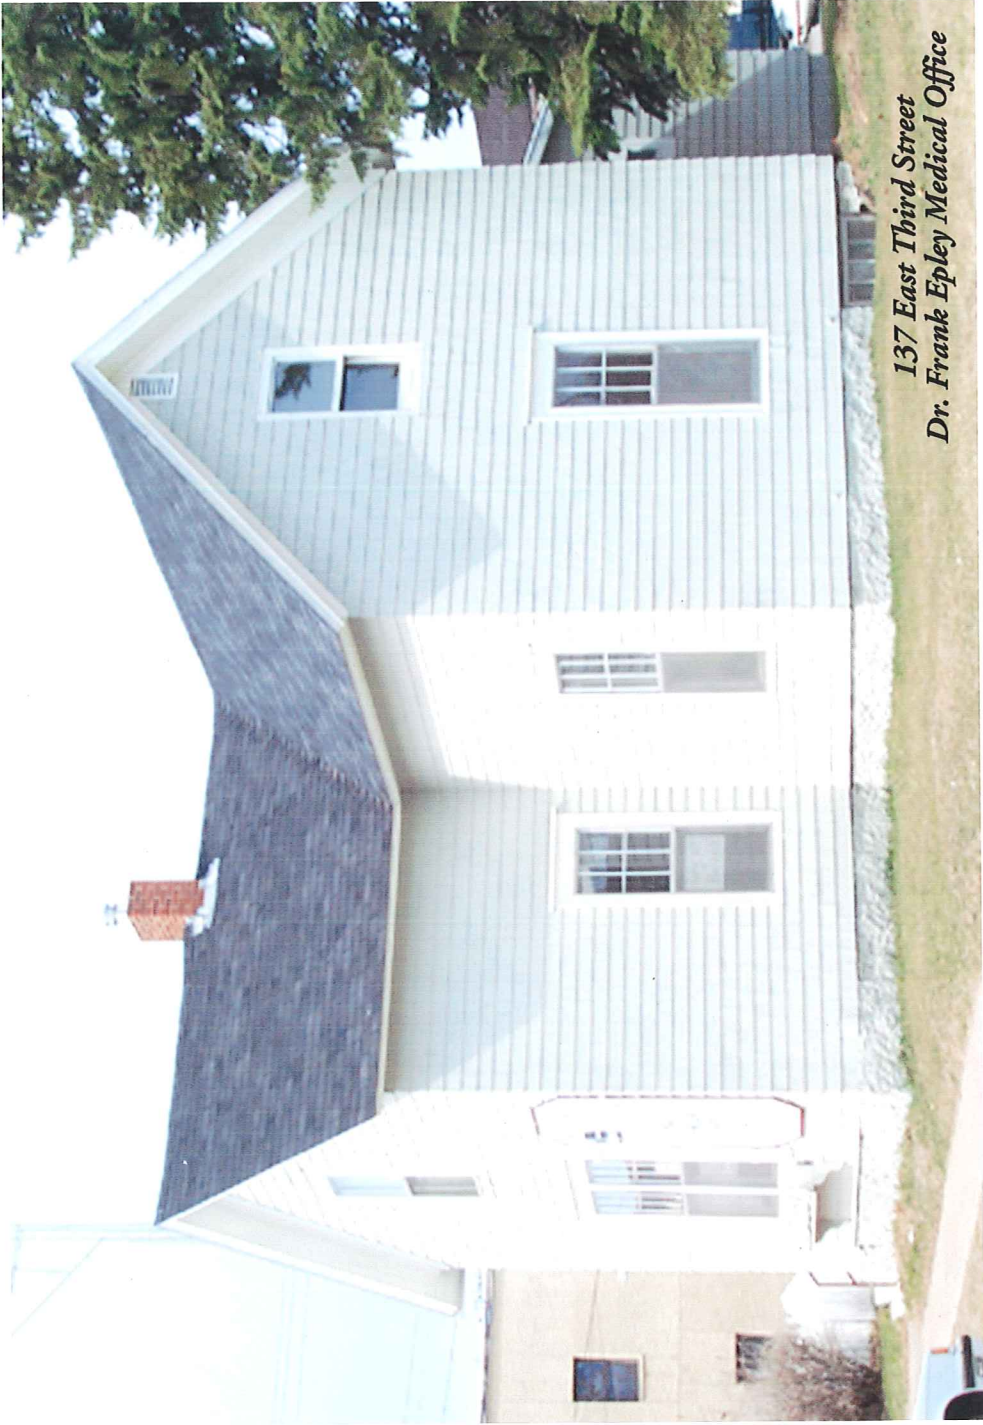
*137 East Third Street
Dr. Frank Epley Medical Office*

- A. Additions to the west and north have muddled the original design.
- B. It appears that part of the north addition is early dating before 1912 and may be considered "historic".
- C. A gable-roofed entry replaced the original small open porch. As it stands today, this porch and the north porch with its six light windows are sympathetic to the general appearance of the building.

D. The placement and design of the door on the west side and the air conditioner are unsympathetic to the character of the building.

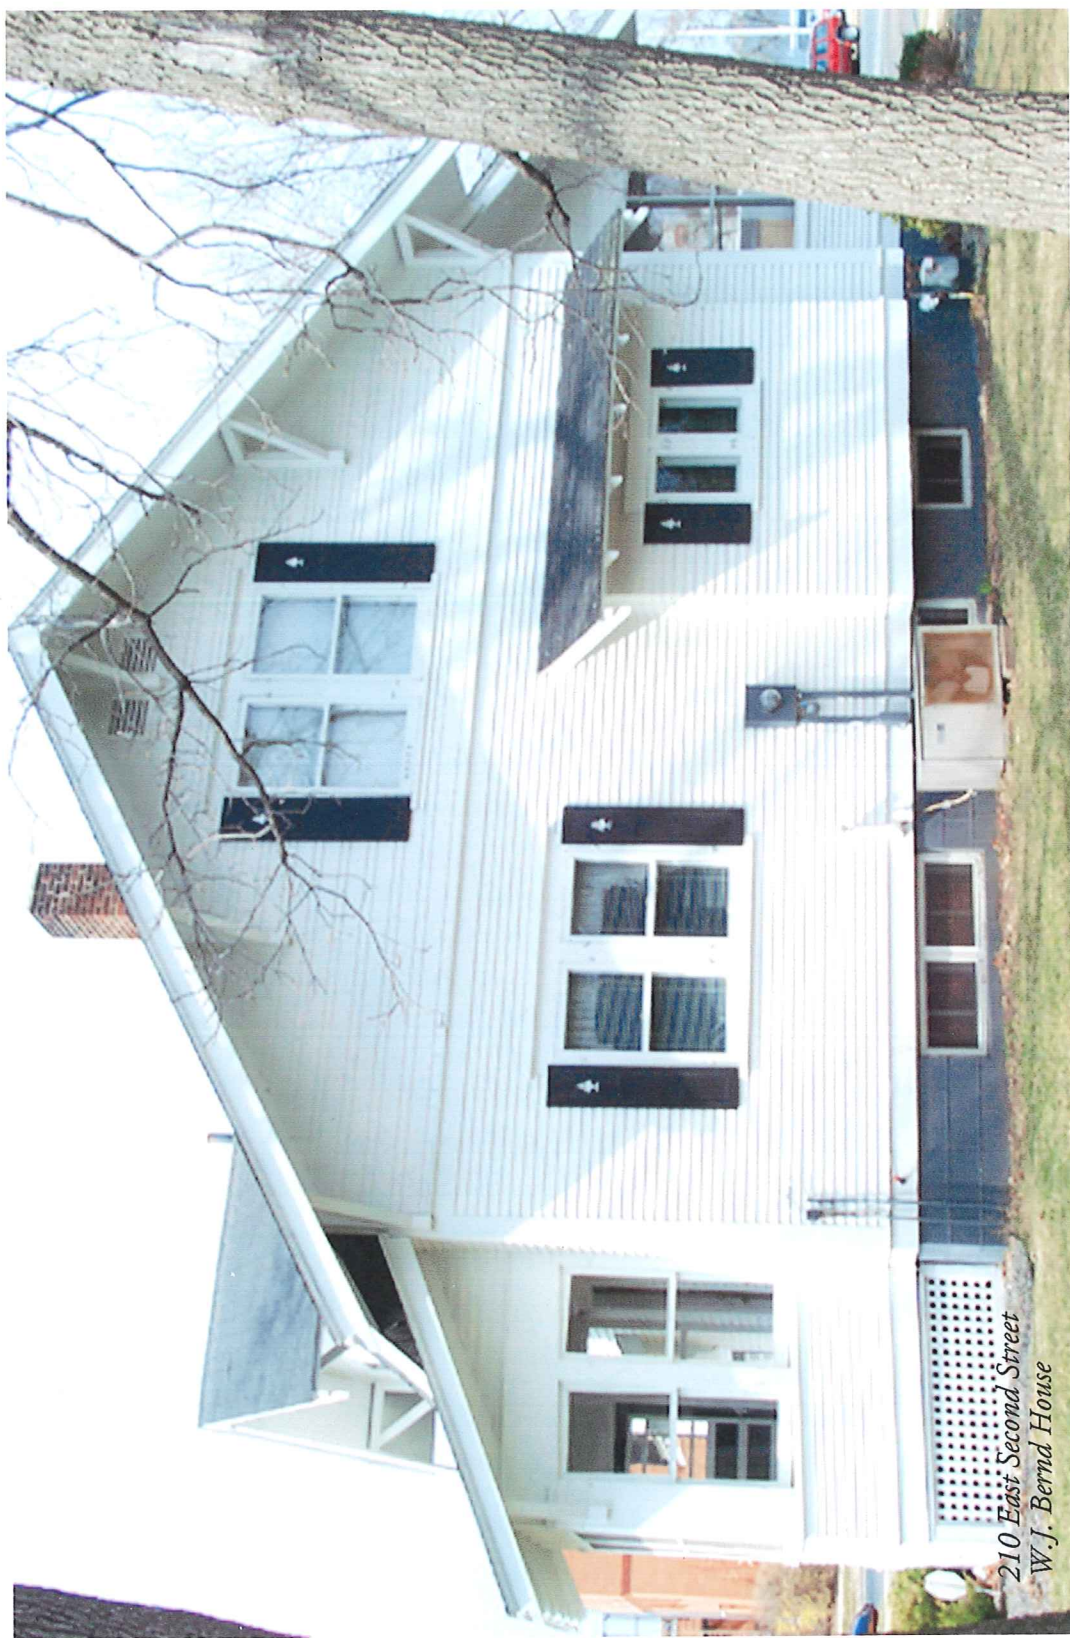
210 East Second Street
W.J. Bernd House

A. The foundation is of smooth block with a raised mortar joint. Often these raised joints were tinted red. Most often the raised mortar joint is found in rock-textured block this is a rare example on flat faced block.

B. The color of the foundation is inappropriate, it ought to be painted a masonry color.

A. It is placed in front of a basement window. When replaced relocate adjacent to wall or away from building.

- A. There are few small exterior siding, painting repair and items which if undertaken will extend the life of the generally well preserved original wood exterior. These are within the common practice of house painters.

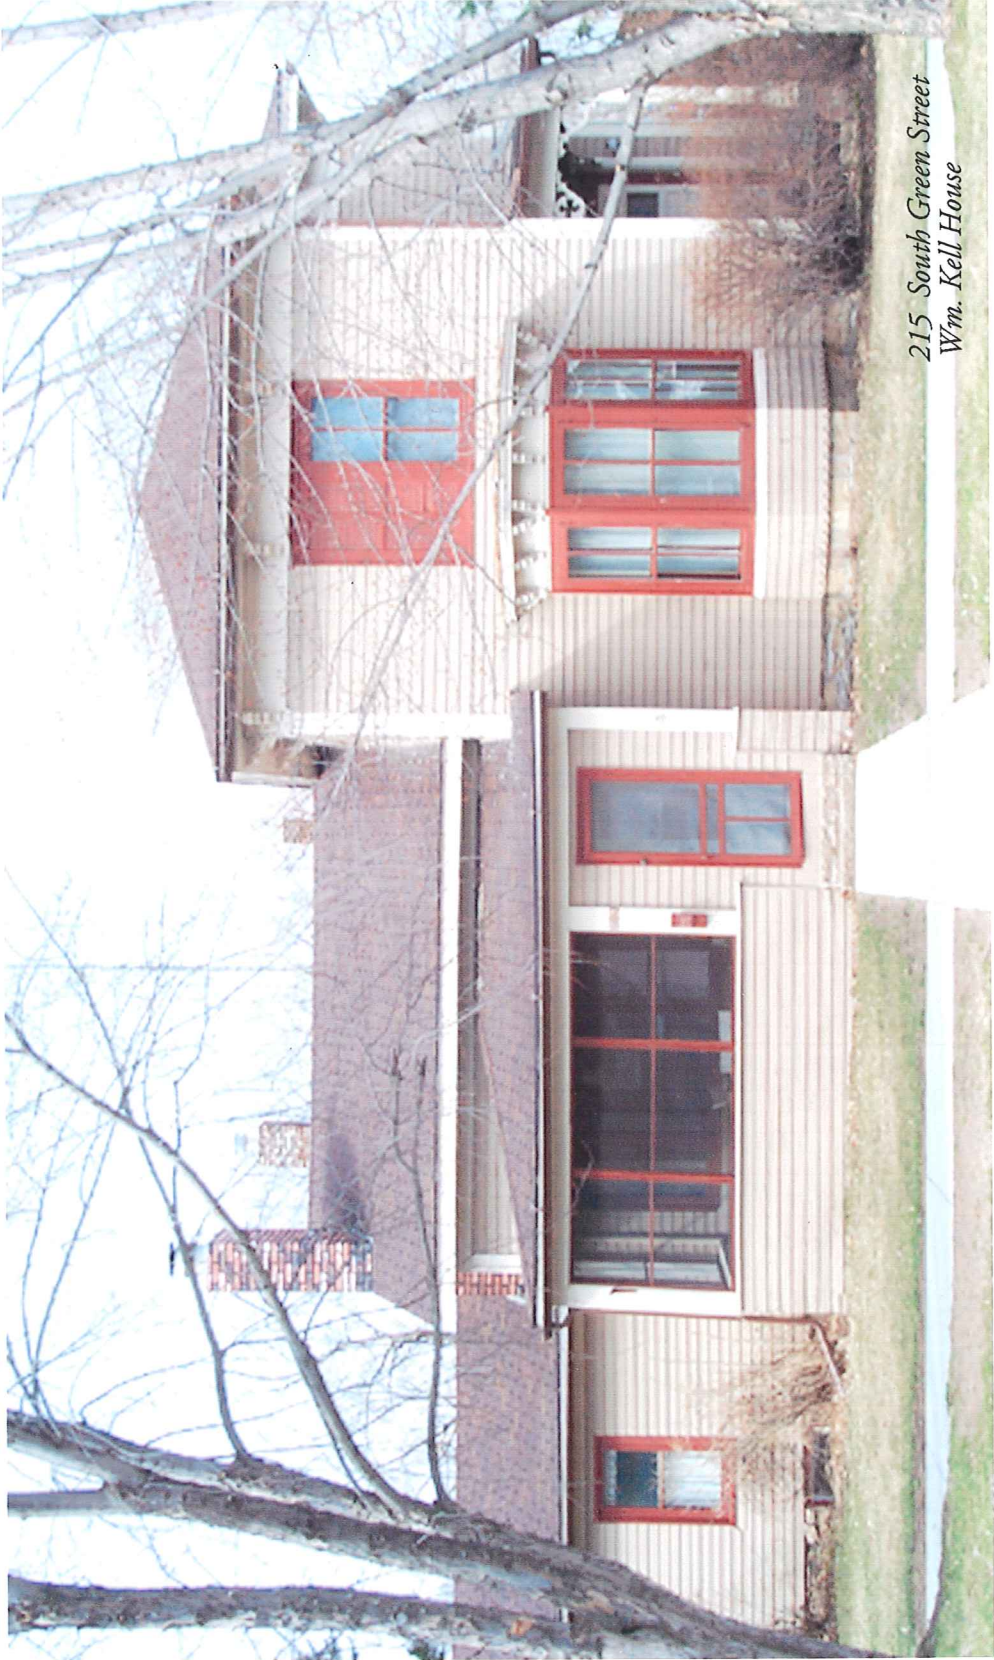
215 South Green Street
Wm. Kell House

A. Some of the eaves have gutters which do not match the adjacent trim. Painting them would help.

B. Most of these houses were built without gutters; larger examples often have built in gutters in the eave. Were it at all possible, eliminating the gutters here would greatly provide a cleaner expression of the original design of the house.
